# TROUBLESHOOTING YOUR RIFLE and SHOTGUN

By J. B. Wood

**Do-it-Yourself  
Diagnosis and Repair  
for Rifles and Shotguns**

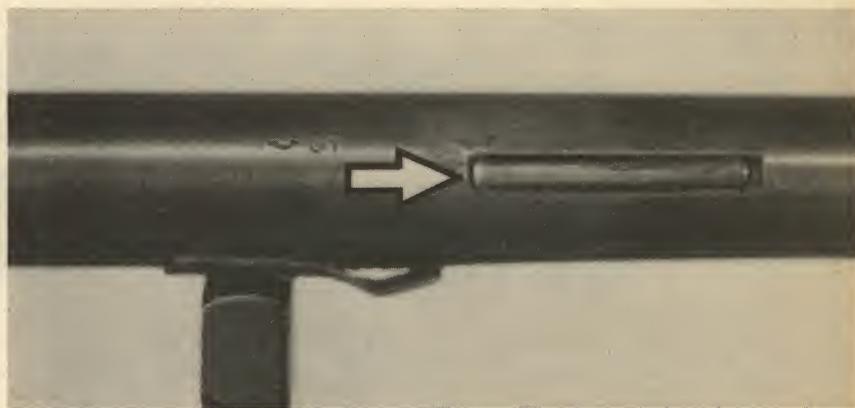
The 552's ejector is keyed in place by its twin rear projections. For removal (bolt must be out), the ejector is pulled outward by its forward end (arrow).

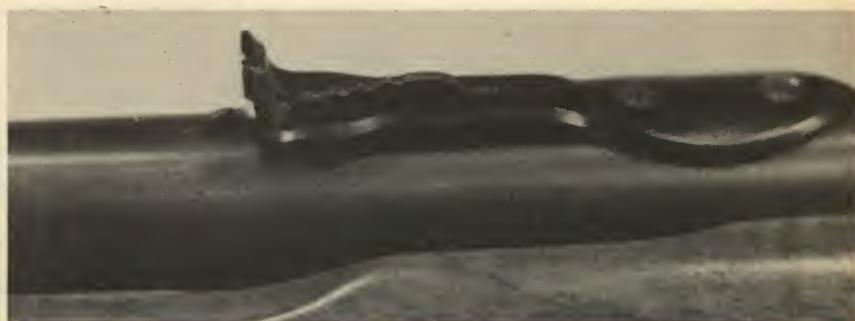
Still in production, the Model 552 has a receiver and trigger group of alloy. In an unusual arrangement, the bolt cocking handle is on the left side, forward of the receiver, and the recoil spring surrounds the rear portion of the magazine tube. On some of the guns, the rear sight is also of alloy, in the same shape as the original steel sight. These alloy sights are less resistant to breakage than the ones of steel.

On some 552s, the rear sight is made of alloy—these are somewhat less durable than the steel type.

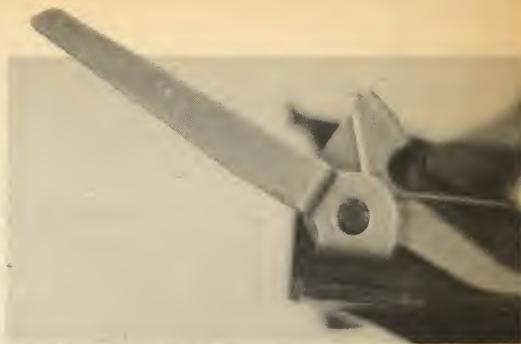
Another part that should be handled with care during takedown and reassembly is the disconnector, the long arm extending forward from the left side of the trigger housing. If it becomes deformed, it will fail to properly contact the rear edge of the action bar and will also bind the magazine. The disconnector can usually be straightened, but it's best left to a gunsmith, as this is a hardened part and will snap off if this is tried cold.

The long forward arms of the disconnector, located on the left side of the trigger housing, can be deformed during careless reassembly.

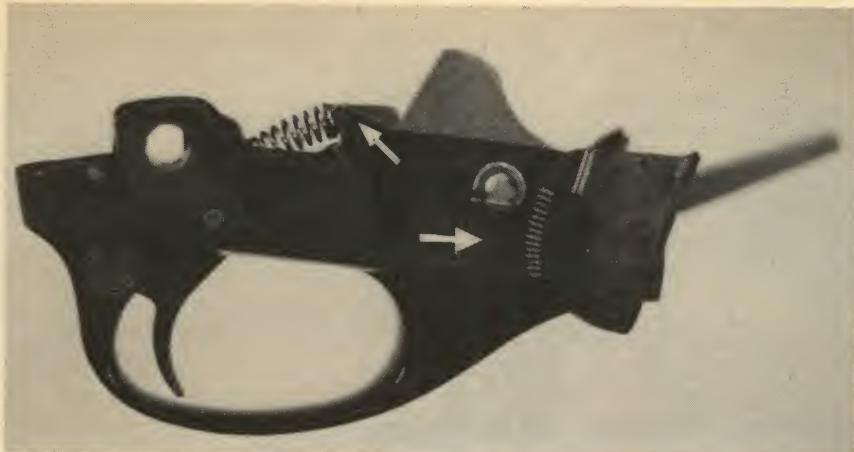
Combination sear and trigger spring (left arrow) can be lost during careless disassembly. The magazine catch and its spring (right arrow) are even more easily detached when the trigger housing is out of the gun.

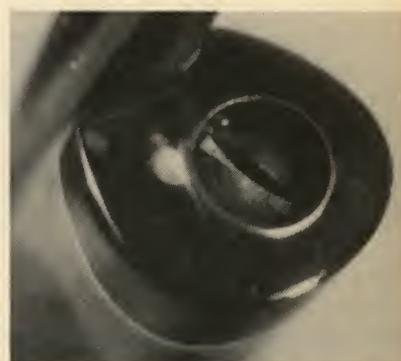
On late guns, there is a large screw at the front of the forend piece, and this screw should be checked occasionally for tightness. The action tube assembly must also be kept tight, but unless it has been removed since installation at the factory, it probably will need no attention. If this is loose, it will be immediately apparent, as it retains the barrel in the receiver!

Be sure the forend screw is checked occasionally for tightness.

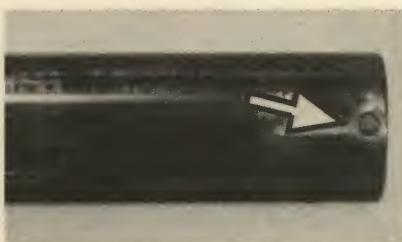
nicely recessed to enclose the entire head of the cartridge; and, the crescent-shaped extractor, which is tempered to be its own spring, is mounted in a groove inside the recess. The extractor is attached by a single tiny rivet which passes through the side wall of the bolt and a hole in the spring-end of the extractor. The extractor will frequently fracture at the rivet-hole. Both the extractor and its rivet are very inexpensive, but installation is an interesting operation, and one that is best left to the professional.

As can be seen here, the extractor is retained inside the bolt face recess by a small rivet (arrow). Replacement is rather difficult.

When the extractor breaks—it usually happens at its rivet-hole—replacement is definitely a job for the gunsmith.

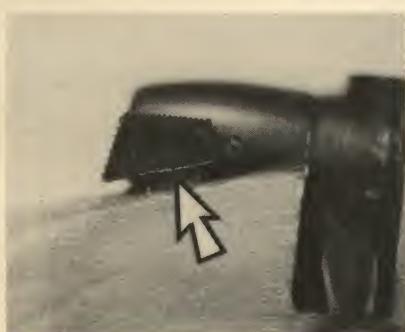
Another plastic part is the operating knob of the manual safety. When this is broken, the entire safety-lever must be replaced.

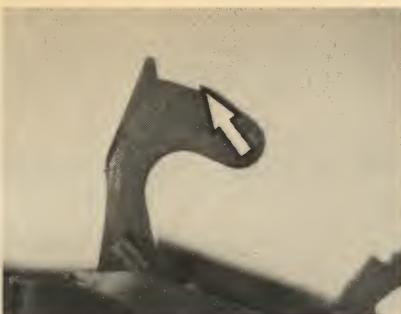
By simply driving out two spring-detained cross-pins in the receiver, the entire trigger group can be removed, and the group and the inside of the receiver sprayed clean with solvent. The gun can usually be sufficiently cleaned this way, and no attempt should be made to dismantle the contents of the trigger housing. The non-gunsmiths who do this often manage to replace the disconnector arm of the trigger and the rear arm of the slide latch in reversed position of engagement, and this is only one of several opportunities for misassembly. While on the subject of amateur tinkering, it might be wise to mention that I have never seen a worn-out hammer and sear in an 870, but I have seen several in which someone had attempted to "adjust" the trigger pull by grinding on the sear and/or the sear step on the hammer, with disastrous results. Be-

Here the arrow indicates the sear step on the rear lobe of the hammer. This is not a problem area in normal operation, but amateur attempts to adjust the trigger pull will usually ruin the hammer.

cause of the design of the sear and hammer engagement in this gun, it's best to leave it as fitted by the factory. A professional can smooth up the pull, if necessary, but the angle should not be changed.

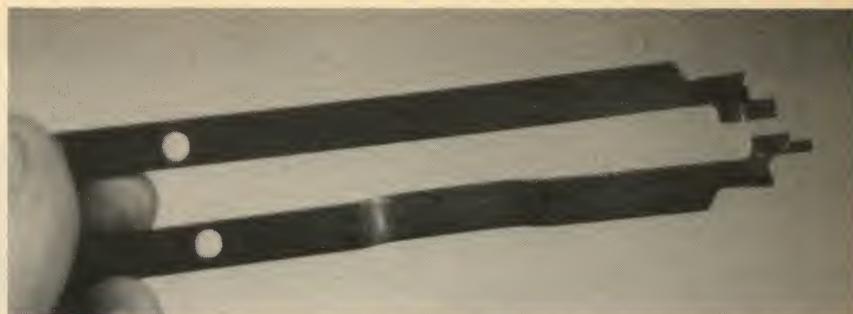
The shell stops, which control the release of the shells from the magazine during feeding, lie in shallow wells on each side of the receiver near the lower edge. These two parts are formed of flat steel stock, and tempered after shaping. They extend almost the full length of the receiver, being retained at the rear by having the edges of their receiver recesses peened over into twin notches in each part. The forward ends of the stops have a rather complicated shape, with curved fingers to contact the shells, and side tabs which are acted upon by beveled surfaces on the slide bars. These parts rarely break but, after many years of hard use, one or the other of them may lose some spring tension and begin releasing shells at the wrong time. It is possible to reshape the shell stops to restore the proper tension, but since parts are readily available at almost every gun shop in the country, replacement might make as much sense. New replacements will often require some fitting, so it's best to leave this job to a gunsmith.

Right and left shell stops are shaped irregularly and are not supposed to be "straight." They occasionally require adjustment, but this is a job for the professional.

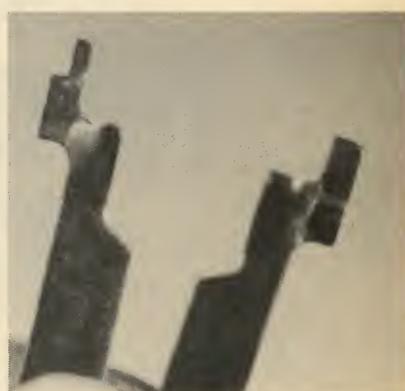
A close view of the shell stops shows the complicated form of their shell contact tips.

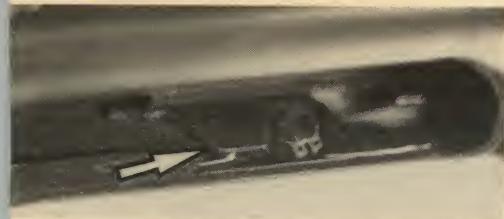
The interceptor latch (arrow) has a narrow rear projection which is struck by the disconnector in its downward arc. The rear arm will occasionally break.

There is one internal part which gives occasional trouble. The interceptor latch—one of the two shell stops—is located inside the left wall of the receiver at the front lower edge. It has a narrow extension to the rear, the underside of which is grooved for a torsion-type spring. During the firing cycle, this rear arm is struck by the disconnector in its downward movement, and I have seen a few cases of breakage in this area. The part is not expensive, but replacement is rather difficult without a special tool to release its retaining clip-ring, and this job should be left to your gunsmith. Fortunately, this doesn't happen often.

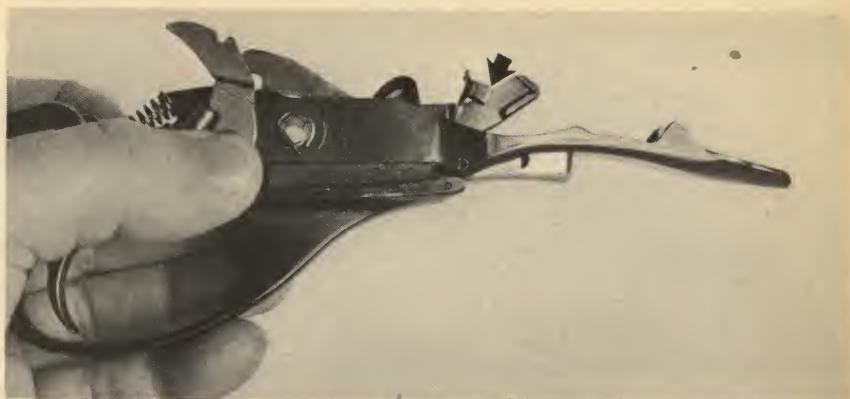
During the firing and feeding cycle, the carrier latch is activated by being struck by the head of the next shell fed from the magazine onto the carrier. If the magazine spring has become weak, the fed shell may have inade-

The carrier latch (arrow) is activated by the head of the shell as it travels from the magazine onto the carrier. A weak magazine spring may cause failure to disengage.

quate energy when propelled back against the catch, and may fail to disengage it. The simplest way to correct this is to replace the magazine spring with a new one having full strength. If a replacement magazine spring is not immediately available, the same effect may be obtained by an adjustment of the carrier latch spring, but view this as a temporary repair.

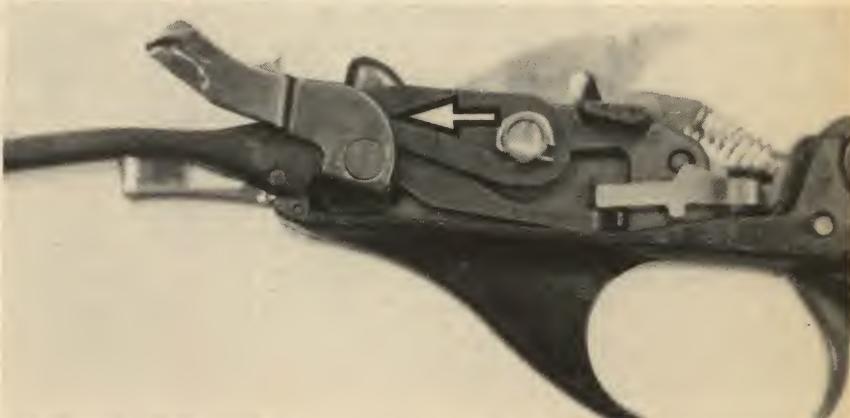
Here, the arrow points to the disconnector which is subject to wear at its contact point with the action bar.

The disconnector, located on the left side of the trigger housing at its forward edge, is subject to wear at its contact point with the action bar, but it takes a good many rounds over the years before wear will be of any significance. More often, in amateur reassembly, the forward arm of the disconnector can be bent out of alignment to the point that it no longer makes proper contact with the action bar and the interceptor latch. Unless the deformity is very severe, it can usually be repaired.

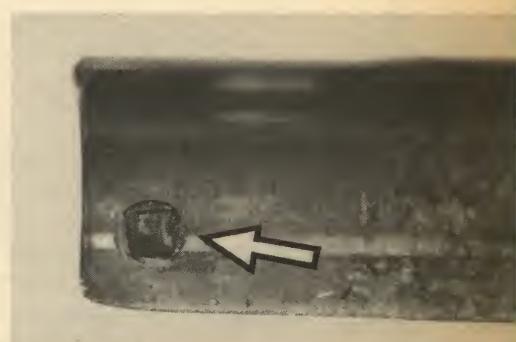
The ejector is a simple, solid stud that is rivet-mounted in the left wall of the barrel extension. I do not know of any incidence of breakage, but if one of these should chip off, it would not be difficult to repair. All parts are, of course, available at most gun shops, and from the factory.

Breakage of the ejector (arrow) is rare. It's rivet-mounted in the left wall of the barrel extension.

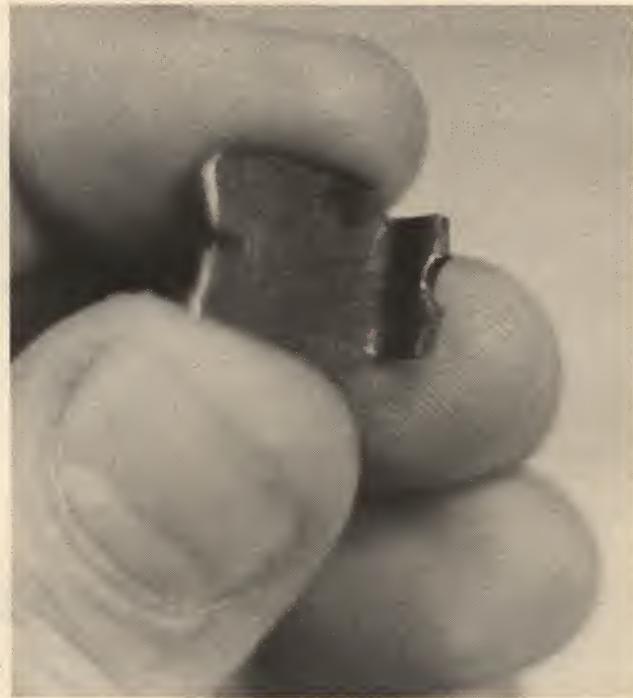
locks into the endcap's serrated inner edge. The detent plate is screw-mounted to the bottom of the receiver, and these will occasionally break at the screw hole. This part is not absolutely essential, as the end piece can often be tightened sufficiently to prevent loosening. If not, and if a new detent plate is not available, a lower edge of the receiver can be staked into the cap serrations to hold it in place.

The detent plate for the receiver end piece is screw-mounted in the bottom of the receiver, and occasionally breaks at the screw hole.

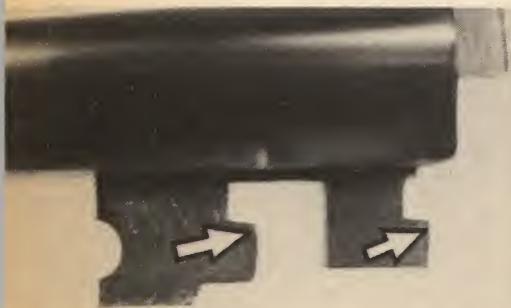
The barrel latch system of this gun is particularly good, a sliding plate bearing on double lugs below the barrels. If years of shooting should slightly loosen the action, it can be tightened by careful peening of the rear face of the lugs, just below the step, to raise the locking surfaces. Since the Rossi guns I have examined close with a vault-like click, I doubt that this operation will be needed in the near future.

The Rossi has a very strong barrel latching system, with double lugs. After years of shooting the action may become loose; it can be tightened by peening at the points indicated by the arrows.

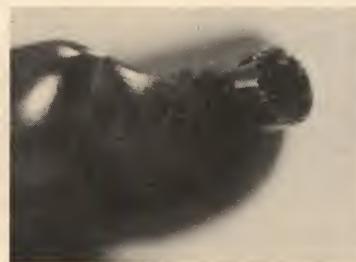
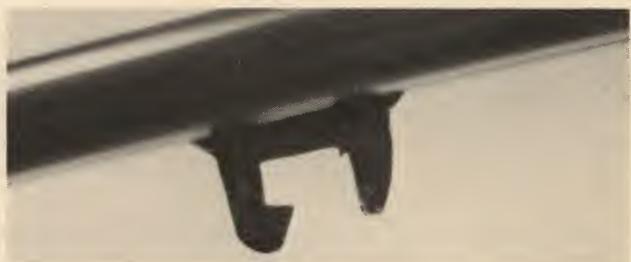
The forend latch (left) is a push-button type, and its latch lug on the barrels (right) has an angled beak that automatically tightens as it wears.

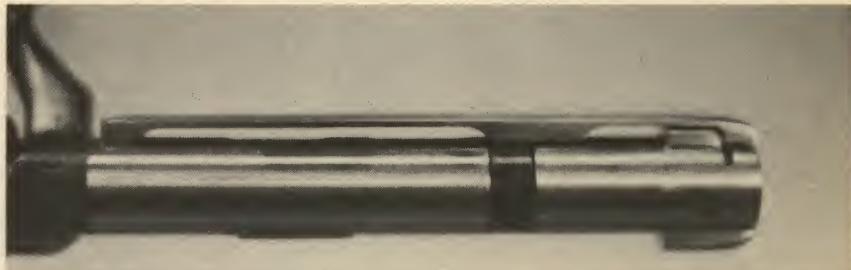
Of classic Mauser design, the extractor is tempered to be its own spring. Breakage is quite rare.

Of Mauser pattern, the extractor is mounted outside the bolt body, and retained by the usual T-slot and ring arrangement. It is tempered to be its own spring; and, I suppose with a long passage of time one of these might weaken and require replacement or retempering, but this is looking far into the future. Both the extractor and its retaining ring seem to be slightly heavier than the original Mauser type, and I doubt that breakage will ever be

a problem. If it does happen, it will probably occur during amateur take-down or reassembly of the bolt. The bolt can be taken apart without much difficulty, but the extractor should not be removed except in cases of repair.

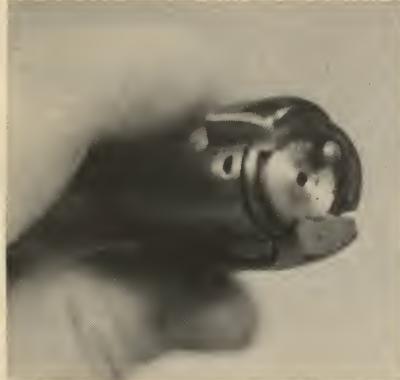
The bolt face has a half-shroud, and the ejector is a spring-and-plunger type. Note the large, well-shaped extractor beak.

The bolt face has a half-shroud, and the ejector is a spring-and-plunger type that should be entirely trouble-free. If the ejection should become sleepy after many years of use, it will be a simple matter to install a stronger ejector spring. The ejector spring is made of helical coil, and the plunger is retained by a simple cross-pin. The

pin should be checked for tightness and staked if necessary, because if it should loosen and creep out, it can catch on the edge of the bolt lug recess and jam the action.

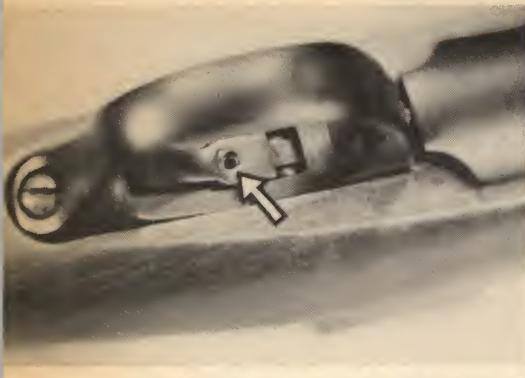
Weight of the trigger pull is adjustable by means of this Allen screw (arrow) without removal of the action from the stock.

Trigger pull weight can be adjusted without taking the action out of the stock, by means of an Allen screw in the top underside of the trigger. For adjustment of the trigger and sear engagement, and over-travel, the action must be removed. The pull adjustment is done by simply turning the Allen screw, but the other adjustments should be done by a gunsmith. The engagement screw, in particular, should not be disturbed by the amateur.

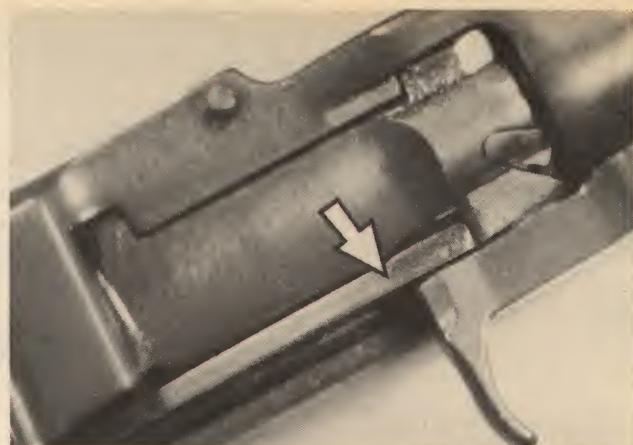
like that gun, and its ancestor the Garand, the right rail of the receiver is not fragile. On the Mini-14 this area is heavier, and any problem from wear is unlikely.

On the original military rifle the right rail of the receiver was a weak point—it's stronger on the Ruger.

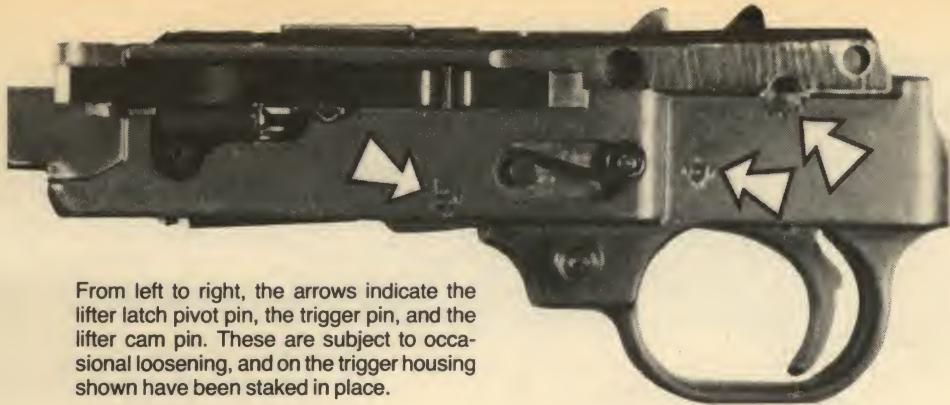
From left to right, the arrows indicate the lifter latch pivot pin, the trigger pin, and the lifter cam pin. These are subject to occasional loosening, and on the trigger housing shown have been staked in place.

certain parts because of the heavy recoil. In revolvers, the screws tend to back out, a condition often cured by a drop of Loctite. Later revolvers have nylon plugs set into the threads to prevent loosening. In the Ruger carbine, this same problem applies to several of the pivot pins. In the trigger housing, the ones usually affected are the lifter latch pivot pin, the trigger pin, and the lifter cam pin. The cure for this is simple and easy—just use a small punch to make stake marks beside each of the pins, on both sides of the housing.

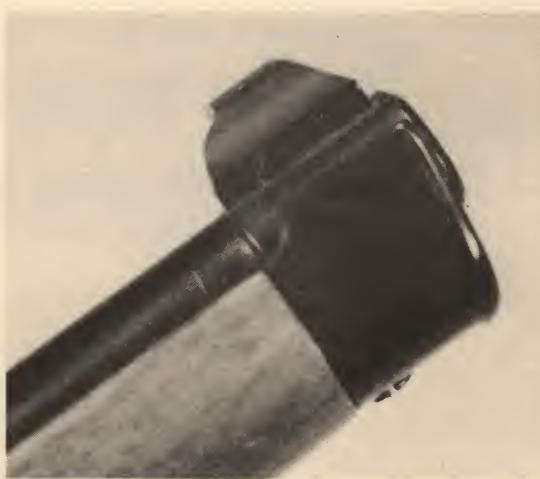
On the International model, the stock endpiece often fits the muzzle rather tightly. If this part is exceptionally tight you'll have to remove it in order to get the action free of the stock. *CAUTION:* While parts for the basic Ruger 10/22 Carbine are readily available (and will serve to repair the International style Carbine), external parts such as the International style stock and all its accompanying furniture are completely exhausted. Exercise care in disassembling the International—if something gives or breaks you're in for a trip to an experienced gunsmith.

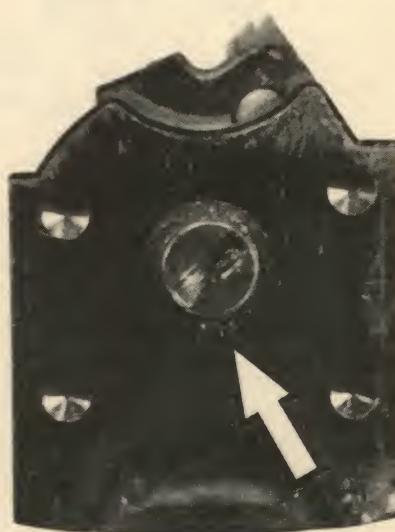
see that it stays tight, but otherwise, don't fool with it. If you back it out, it will release the hexagon-headed end of the rotor shaft from its recess at the rear and let the tension off the rotor spring. Regulating this is a job for a gunsmith unless you are thoroughly familiar with the construction of the magazine.

At the front of the magazine is a coin-slotted screw (arrow). It should be checked occasionally for tightness, but the amateur should resist any temptation to remove it.

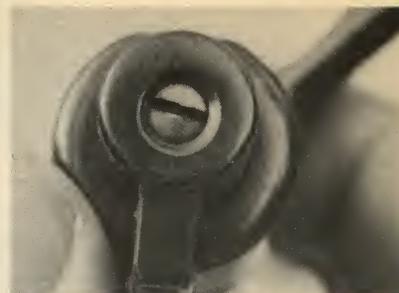
At the rear center of the cocking piece is what appears to be a screw, but this is definitely not the case. This is actually the rear tip of the firing pin, which is threaded into the cocking piece, and the screw slot simply allows adjustment of the protrusion of the firing pin point from the breech face. This adjustment is not the sort of thing that should be attempted by the amateur, as a miscalculation can

What appears to be a screw is actually the rear tip of the firing pin shaft. This should not be disturbed by the amateur.

cause either misfiring or pierced primers. For the benefit of any gunsmiths who might be reading this, the proper protrusion is .055-inch, and you'll need one of those neat little gauges that Brownells, Inc. sells for around \$10. On the underside of the cocking piece there is a small set-screw which locks the firing pin adjustment, and this one should be kept tight.

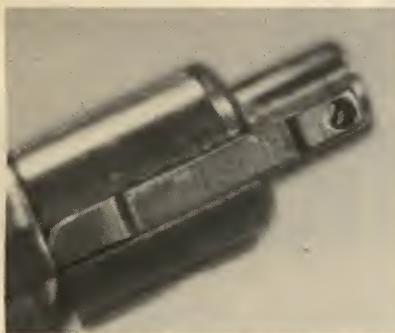
In this underside-view of the bolt endpiece, the small screw visible at far right locks the firing pin, which is threaded into the cocking piece. This screw must be kept tight.

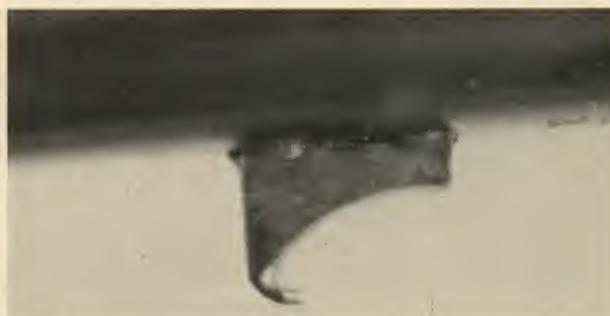
Because of the heavy, snake-like spring that forms the forend latch, forend retention on these guns is very firm, and that's good. For some, who take these guns apart frequently for stowage in a camping pack, the forend latch may seem too stiff, and I have seen some cases in which the latch lug on the lower barrel had been filed to lighten the compression of the spring. I don't approve of softening this latch at all, but if it must be done, *don't* do it that way, as the thinning of the lug will eventually cause breakage. Instead, remove a very small amount of steel from the tip of the wavy blade spring of the latch.

Usually, the forend latch of the Model 24 is very tight. In an effort to make it work more easily, the owner of this gun has altered the lug on the barrel, making it dangerously weak.

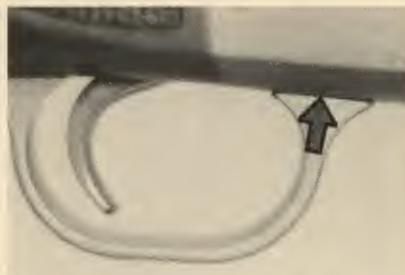
The trigger guard is retained by two screws, the rear one entering the lower tang from the outside, where it can easily be checked for looseness. When the front screw loosens, it's a real problem, since it enters the front base of the guard from *inside* the re-

ceiver, its head hidden below the hammer and barrel latch assembly. To avoid taking the gun completely apart, it's possible to tighten this screw if you can find a screwdriver that has a slim shaft and a wide blade. By cocking the hammer and inserting the screwdriver in front of it, you can look into the receiver from the front (with forend and barrels removed) and position the blade of the screwdriver in the slot of the screw.

The front trigger guard screw enters the guard from inside the receiver, at the point indicated by the arrow. Tightening without complete disassembly is not easy.

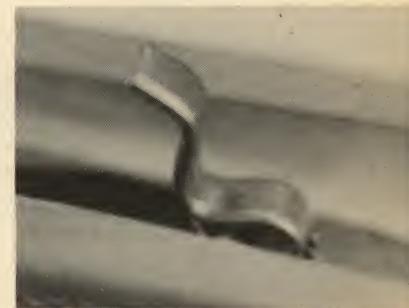
Normally, the snake-like forend latch spring is very stiff. Its action can be eased by removing a tiny amount of steel from its tip.

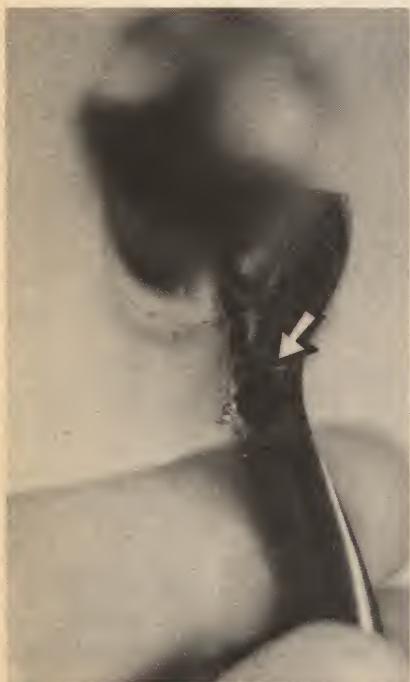
When the safety lever is in the on-safe position, a forward projection enters a hole (arrow) in the bolt handle, locking the bolt against opening. This feature is often removed.

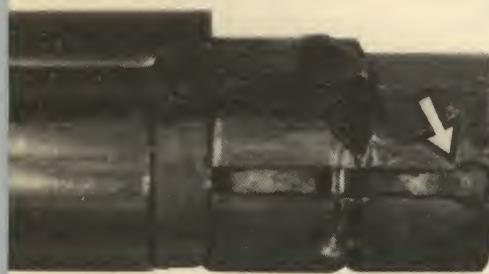
The very small extractor is both retained and powered by a flat spring—the spring held in place by a cross-pin. The system appears fragile, but the design is apparently better than it looks, as breakage is not frequent. In

Arrow points to the small extractor which is both retained and powered by a flat spring. The system appears fragile, but breakage is not frequent.

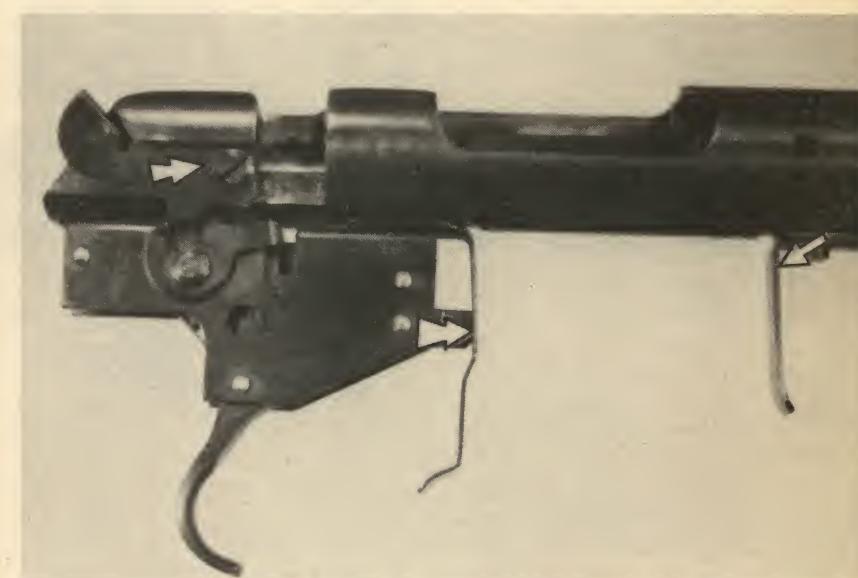
The safety-lever is screw-mounted on the right side of the receiver. This screw also serves as the pivot for the lever, and it should be checked occasionally for tightness. Although it is insured against loss by being inside the stock when the gun is assembled, there is sufficient clearance for looseness to affect the operation of the safety.

The magazine catch is a formed piece of sheet steel, tempered to be its own spring, and occasional weakness is more common than breakage. It can usually be reformed to restore lost tension. Replacements are very inexpensive, but installation requires removal of the trigger housing. Forward of the magazine there is a heavier piece of formed steel which acts as a magazine guide, and this part is occasionally deformed by careless take-down and reassembly. It can usually be reshaped and is easily replaced if this is unsuccessful.

Arrow at upper left indicates the safety lever screw, which should be checked for tightness. Arrow at center points to the magazine catch, which is tempered to be its own spring. The arrow at far right indicates the magazine guide.

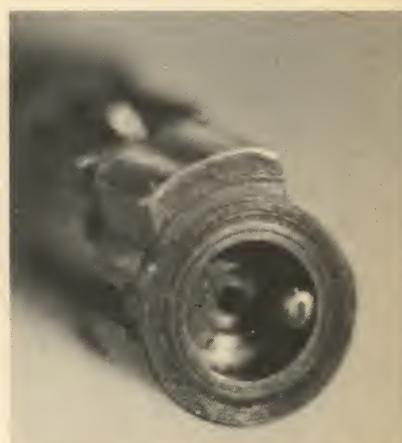
The bolt head has a single locking lug, the bolt handle base serving as a second lug. Note the fully recessed breech face, and the spring-plunger type ejector.

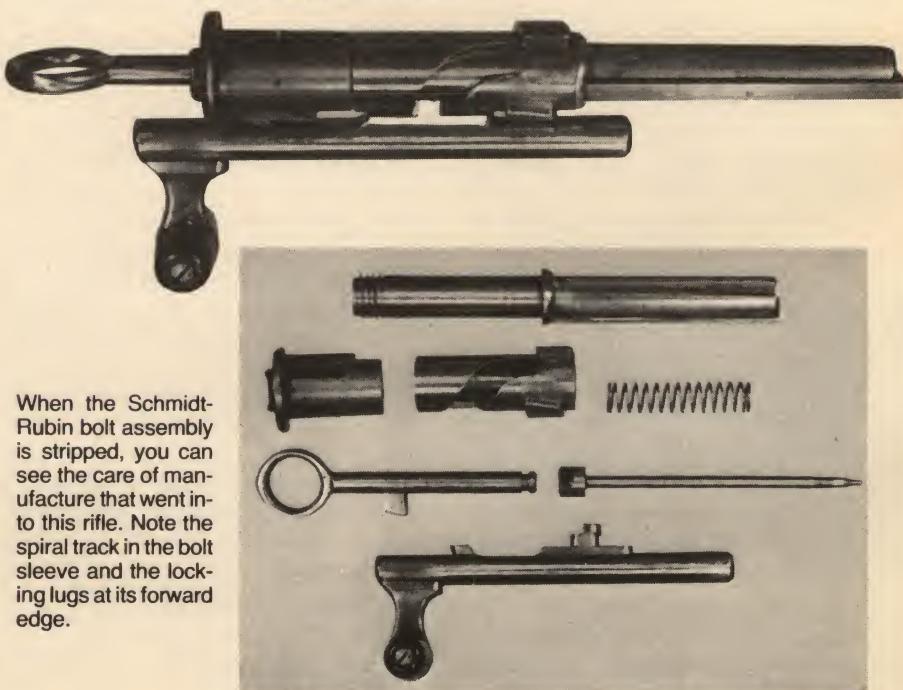
When the Schmidt-Rubin bolt assembly is stripped, you can see the care of manufacture that went into this rifle. Note the spiral track in the bolt sleeve and the locking lugs at its forward edge.

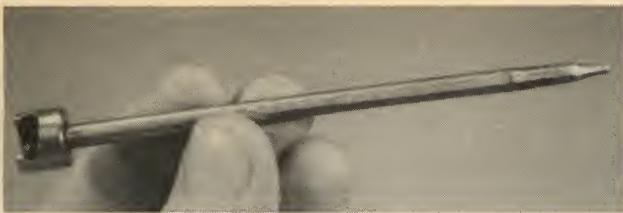
The Schmidt-Rubin's long, slim firing pin is not prone to breakage, and this is fortunate, as making a replacement would be difficult.

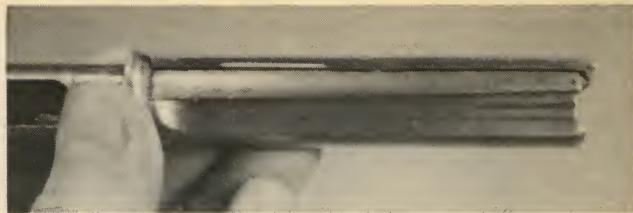
Tempered to be its own spring, the extractor is a heavy part, and it seldom breaks.

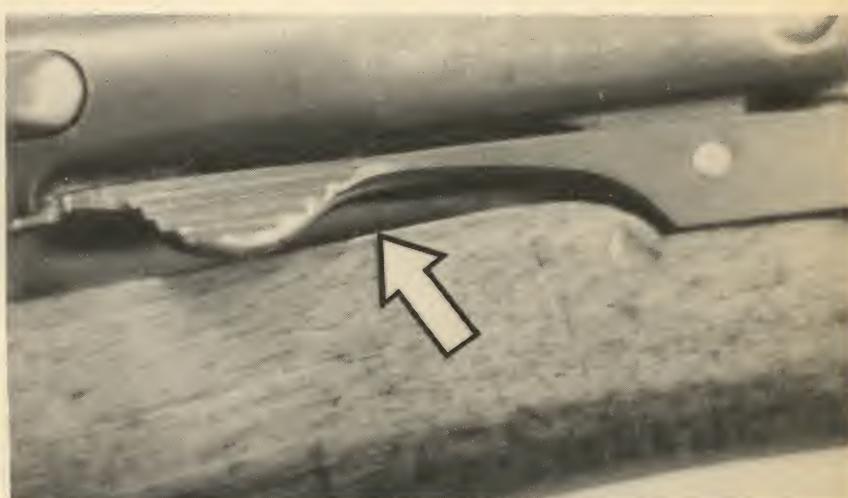
Located on the right side of the receiver is the release lever for bolt removal (arrow). It's pushed downward to free the bolt.

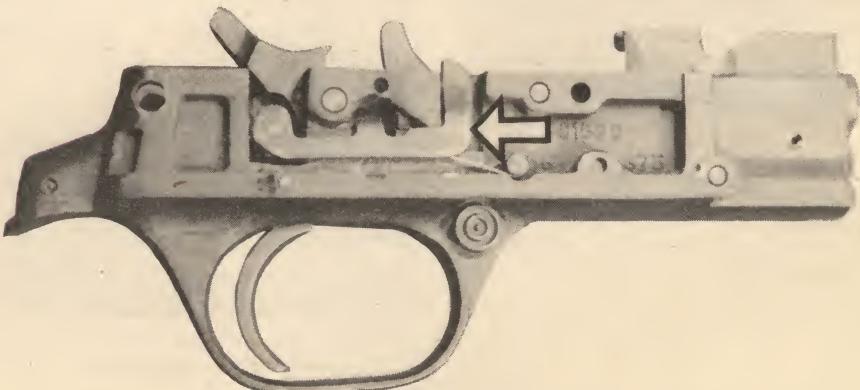
In this view of the right side of the trigger group, the arrow points to the trigger bar/disconnector, a frequent source of trouble.

oted on the trigger at lower rear. Although the upper end of the arm is beveled, the system has poor mechanical advantage, and the arm breaks with some frequency. When replacements were available from Sears, installing a new disconnector took all of 5 minutes and the part was not expensive. Now, you have a real problem, as this part is not of simple shape and is not easily made. I usually square off the broken arm and make a separate vertically-sliding part that will duplicate its function, utilizing the remainder of the original disconnector.

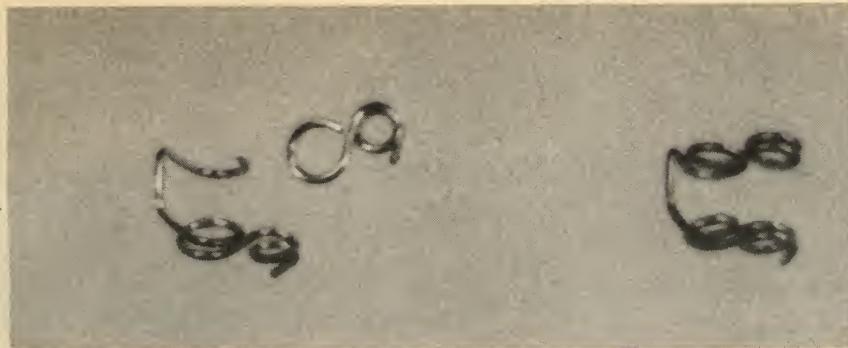
in the bottom of the trigger housing. In operation, this spring is severely flexed, and its design is not suited to this. At this point, I will propose what might be called, "Wood's Law of Gun Parts," as follows: The more weird the design, the more likely it is to cause trouble. When this little monstrosity breaks—and it will, eventually—the installation of a new replace-

A broken cartridge lifter (carrier) spring is to the left while an intact one is to the right. Both of these springs are of original pattern—breakage is not uncommon.

ment, if you can find one, is best left to your gunsmith. I don't even try to find the original type—I replace it with a shop-made spring that has more loop and less severe flexing.

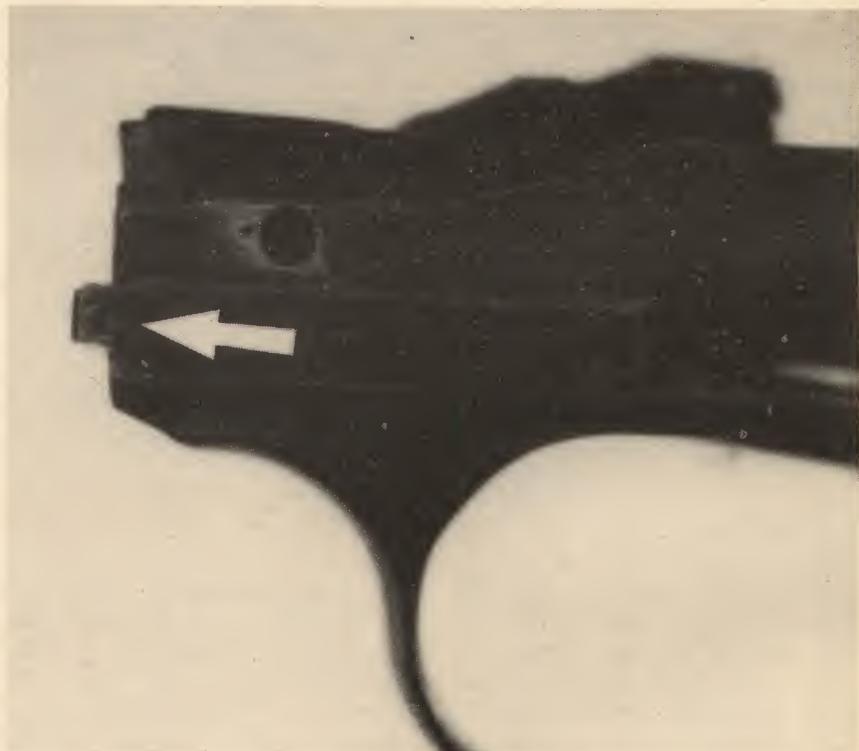
Arrow indicates one of the two opposing retaining lugs found on the forward portion of the trigger group. On the later alloy units, these tend to break off.

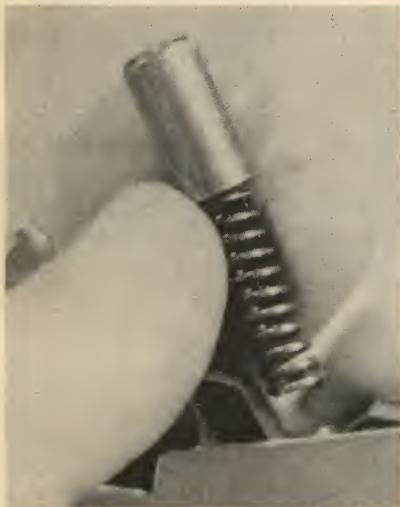
When the trigger group is out of the gun, take care not to pull the trigger without gently lowering the hammer or the hammer spring and sleeve can fly out and become lost.

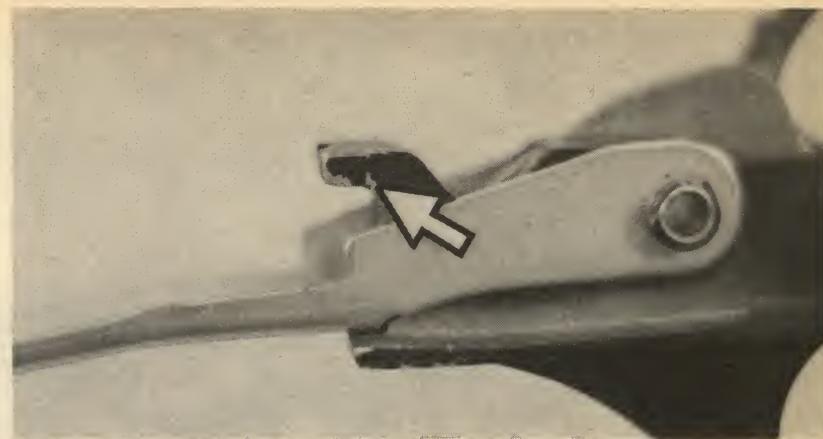
In the entire design the only point that might possibly cause a future problem would be the carrier stop, a projection at the front of the trigger housing. The housing is alloy, and the carrier gives the projection a tap each time the action cycles, so there is a slight chance of breakage in this area after many years of use. On the other hand, the stop is quite heavy, and there seems to be an ample allowance for strength. On this question, time will tell. The ones that I have examined show no signs of strain at this point.

The carrier stop (arrow) is an integral part of the alloy trigger housing. There seems to be an ample allowance for strength.

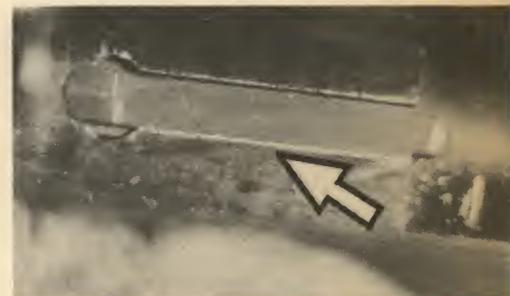
The ejector (arrow) is slot-mounted in the left inner wall of the receiver. Breakage is not likely.

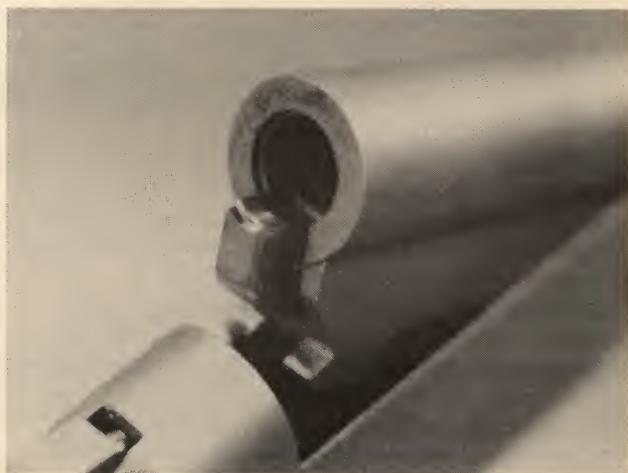
The Snake-Charmer's ejector is a simple, spring-loaded part, without automatic trip. It is large and heavy and not likely to break.

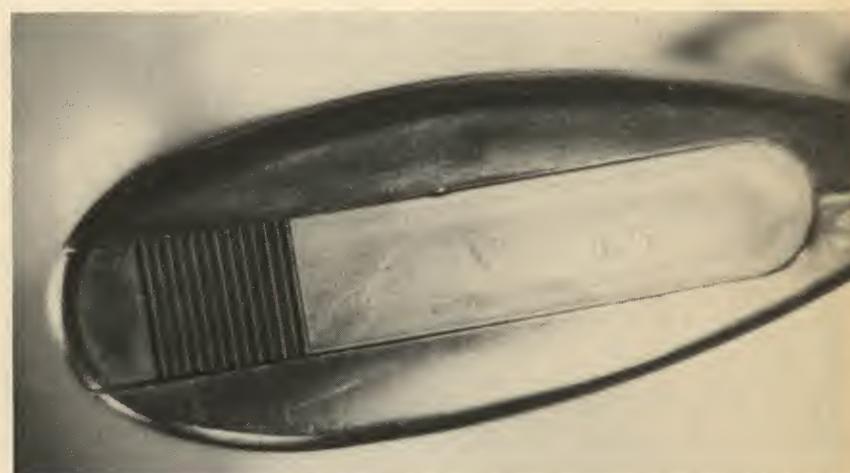
In the butt of the stock is a sliding cover which is moved upward to expose four holes that are just the right size for storage of spare .410 shells. Because of the design of the pistol grip portion of the stock, the top hole will accommodate a 3-inch shell, while the lower three holes will take only the 2½-inch version. Although the stock material is impervious to water, this compartment is not watertight. The sliding lid has a raised nub on its undersurface and is retained in the stock only by friction. Also, there is no stop on the lid—when it is slid upward, it comes completely off, so keeping a couple of extra lids on hand would be a good idea.

Opening the sliding trap in the buttstock (top) gives access to a storage compartment for four .410 shells. (Center) The hole at far left will accommodate a 3-inch shell, but the following three will hold only the 2½-inch version. (Below) While the sliding trap works nicely, it's locked only by a plastic nub—something a bit more positive is needed to prevent loss.

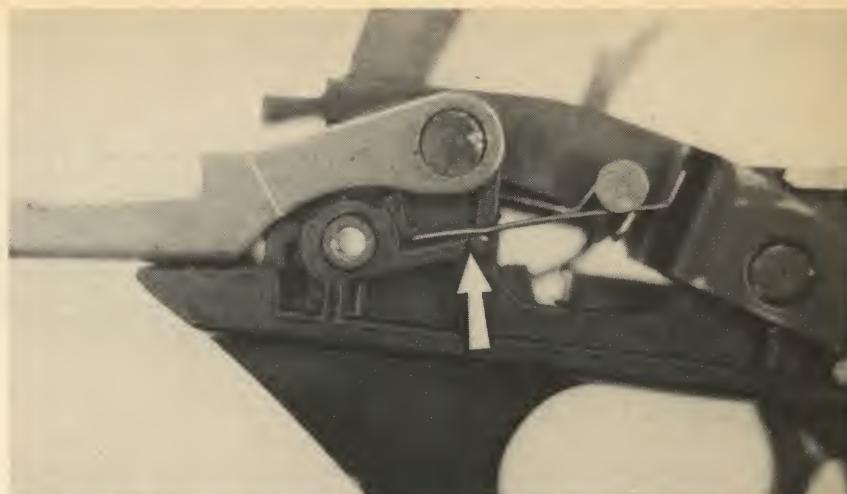
When the slide latch is removed, the slide latch elevation spring (arrow) is easily detached and lost.

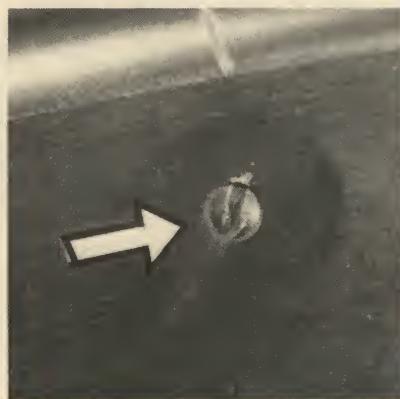
Arrow points to the ejector mounting screw, on the left side of the receiver. It should be occasionally checked for tightness—the one shown has been burried by the use of an improperly-sized screwdriver.

In the same category is the large screw which secures the magazine tube endpiece to its mount below the barrel. In all three screw locations mentioned above, a drop of Loctite on the threads might prevent future difficulty.

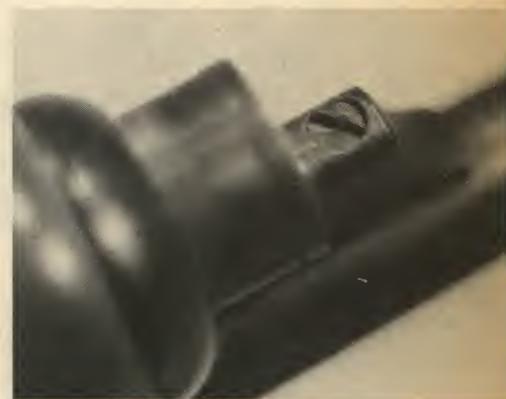
The large screw which holds the magazine tube endpiece beneath the barrel is prone to loosening—check it often.

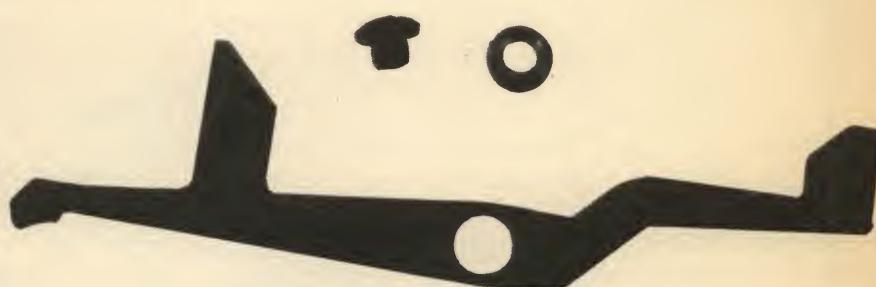
The part that is perhaps the most frequently lost through normal use is the shell stop, an irregularly-shaped piece of flat steel on the lower right, inside the receiver. It is retained by a screw from the outside which threads into a slotted nut on the inside, and all three parts have been known to disappear into the tall grass. These parts are on hand at most gun shops, and any good gunsmith will know to use a special tool to immobilize the nut while setting the mounting screw very tight. This is another one that should

When the shell stop retaining screw loosens too much, the shell stop and its retaining screw and nut can become quickly lost. It is, unfortunately, a common ailment.

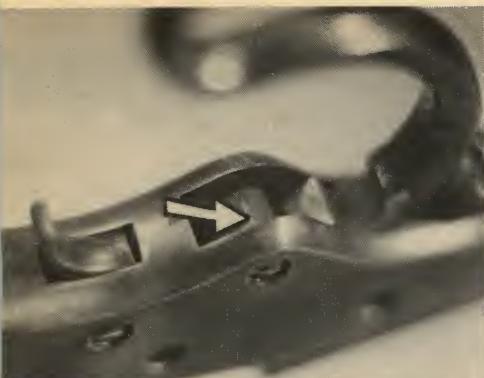
tached to the top loop of the lever at the rear. There is a U-shaped cut in the lever, just inside of the frame when closed, which fits over a screw-mounted roller in the receiver. As the action is closed, the upper edge of the angled U-notch rides over the roller, firmly locking the breech face against the rear of the barrel. Firmly, that is, until long use has worn the action. When this is the case, though, it is easily correctable. The main wear points are the breech block pivot screw, the lever link pin, and the locking roller and screw. Replacement of one or more of these parts will usually restore the lockup to original tight-

Arrow points to the lever lock roller, a part which is subject to considerable stress and wear.

ness. The screws and the link pin are not difficult to make, and the roller is no problem for any good gunsmith. Also, the used-parts dealers occasionally have some parts for these guns.

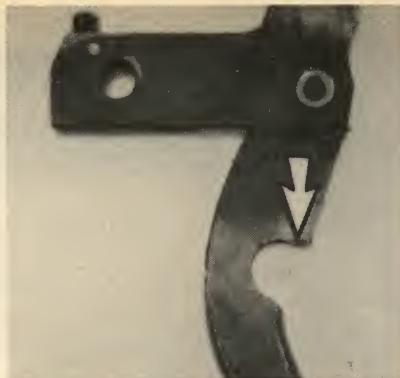
The arrow indicates the area on the lever which locks over the roller in the receiver, a point subject to wear.

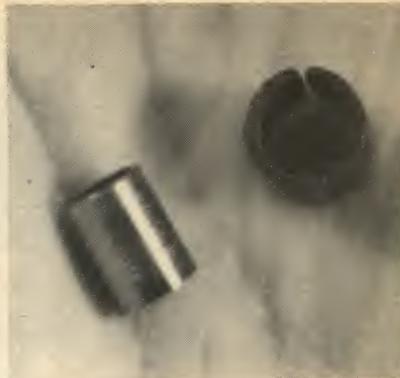
The lever lock roller is originally a solid part, but a good substitute is shown here—two concentric tubes which together attain the proper outside diameter.

Wear is not the only reason for replacement of the locking roller. Perhaps because taking out a single screw drops the roller free, this part is frequently lost. In one recent case, I was temporarily out of the proper size of drill rod to make a replacement roller, and used two concentric tubes to make a sort of "double roller" from a section of a broken auto pistol striker (firing pin) and a half-length of steel roll pin. This combination happened to be exactly the right diameter and worked perfectly.

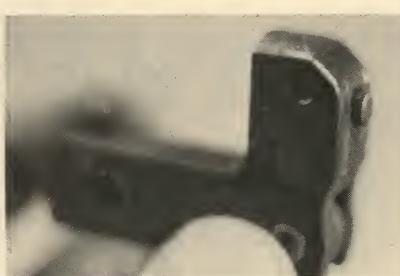
The firing pin of this gun is rather small and has an offset point, making it somewhat difficult to make when an original can't be found. Most amateurs tend to make replacement firing pins too long, and with these there is a good chance of damaging the ejector when the gun is snapped on an empty chamber. With the point of the pin just inside the breech face, the head of the pin should protrude just a small amount at the rear. If the lowered hammer will not fully meet the rear of the breech block with the chamber empty, the firing pin is too long.

When making a replacement firing pin, care must be taken to make it the proper length. With the point just inside the breech face, the rear head should protrude as shown in this view of the breech block.

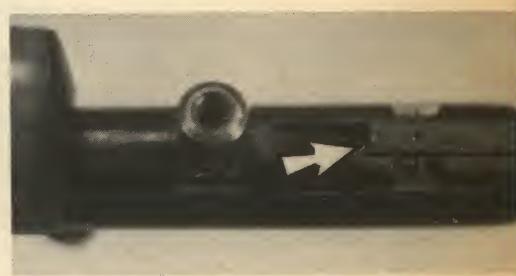
Sliding in a T-slot in the underside of the barrel, the ejector (arrow) is activated by a spring-powered plunger in the forward extension of the breech block.

the ejector is gouged by an over-long firing pin point, or eaten away by the corrosive qualities of early ammunition. This would be a fairly difficult part to reproduce, but fortunately, a modern reproduction is offered by Triple K. The coil spring which powers the ejector plunger in the breech block will occasionally weaken, but this is easily replaced with any modern coil of proper size and weight.

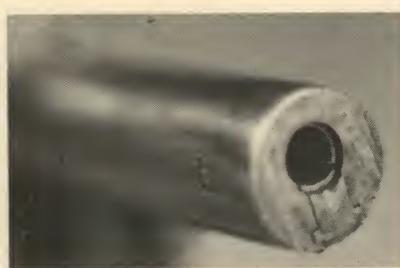
When deciding whether to restore one of these little rifles, a primary consideration should be the condition of the chamber and the ejector. In the example shown here, both are very good.

early ammunition was loaded with blackpowder and corrosive priming, and this combination caused extensive corrosion in the chambers of many of these guns and damage to the barrels as well. When there is severe erosion of the forward part of the chamber, the fired cases will swell into the eroded area, making ejection a matter of prying the cases out. If the gun in question is a family keepsake, justifying the expense, the barrel can be full-length relined, preserving the original exterior. This, of course, should be done by a gunsmith.

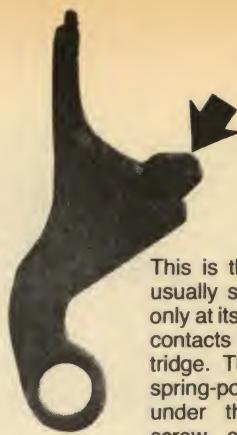
This is the ejector, a part usually subject to damage only at its upper tip, where it contacts the rim of the cartridge. The lug at right is spring-powered, to snap under the breech block screw as the action is opened.

mer falls, the firing pin nose actually pinches the cartridge rim against the ejector, rather than against a solid edge of the barrel as in most other rimfire guns.

There is a positive stop shoulder on the original firing pins to prevent the tip from reaching and damaging the ejector if the gun is snapped while empty, but the rather large retaining groove in this firing pin causes it to have a relatively weak rear section, and breakage is not unusual. Based on examination of a large number of these guns over the past 30 years, it would be safe to say that more than 90 percent of the replacement firing pins were handmade by amateurs, using materials most readily available, such as a large nail. Almost invariably, the replacement firing pin was made too long, and the gun snapped frequently with the chamber empty. Before it bent and ceased to function, the over-long tip of the homemade firing pin would usually succeed in severely damaging the top portion of the ejector. I have repaired these by adding steel weld to the top and recutting to shape, but in order to do this, the plunger and spring must be removed from the ejector, and they are stake-mounted in place, in a blind hole. Removal can be very interesting, to say the least. I do not know of any consistent source for the ejector except Dixie Gun Works, and the price is around \$9, which is most reasonable. They also have a few other parts for the Favorite, but *no* firing pins. For that, you consult your gunsmith.

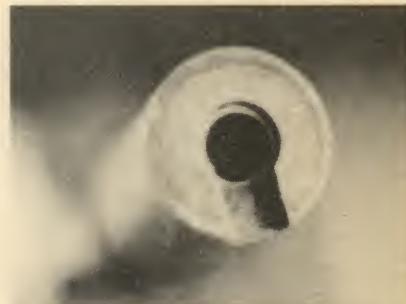
duction guns suffered greatly unless they were scrupulously cleaned after every use, and this was seldom the case. If the chamber is badly eroded, the fired case will swell into the eroded areas, and will stick tightly in the chamber. When deciding whether to restore an old Favorite, check the chamber first, then the ejector and firing pin. If all of these are deficient, you may find it more expedient to buy the Savage/Stevens Model 74, a modern recreation of the Favorite.

When deciding whether or not to restore an old Stevens Favorite, the condition of the chamber is of primary importance. The one shown here is in excellent condition.

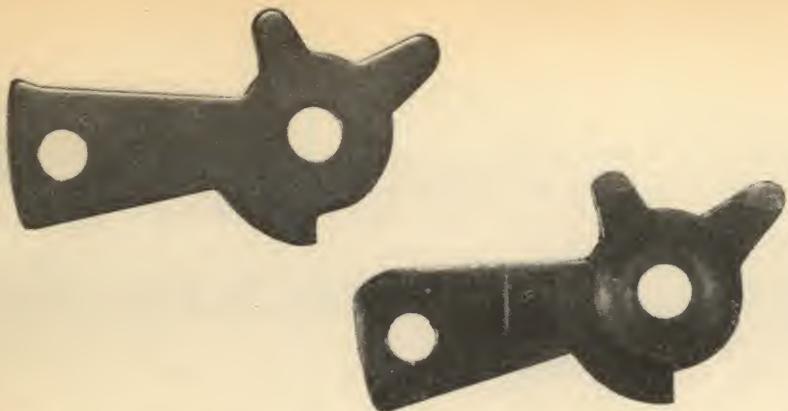
level of the magazine tube up to the feed lips. Its movement is governed by two lobes on top of its pivot end, and wear of these can cause trouble in two ways. A worn lifter will either fail to depress far enough for a cartridge to enter the magazine guide, or fail to rise far enough to position the round in the feed lips. Replacement of the lifter is the remedy, and fortunately parts are still available from the manufacturer, Savage. A weak lifter

A new cartridge lifter is shown at the top, while the one below, badly worn, was causing misfeeding.
